Grass reinforcement for overflow parking area

Client: Southend Borough Council
Project: Grassed Overflow Car Park
Contractor: East Beach, Shoeburyness, Essex
Product(s): GRASSPROTECTA™ (Heavy)

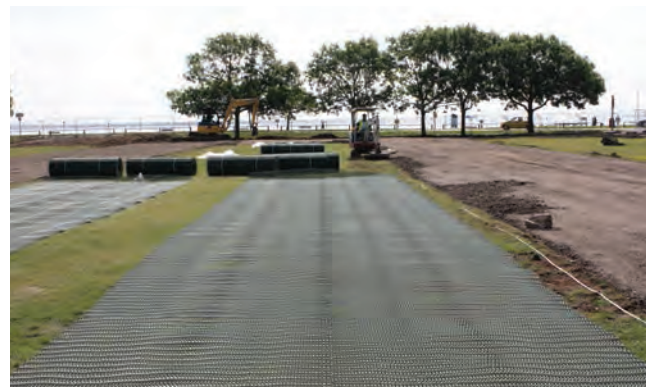
The East Beach car park offers year-round parking for all visitors to East Beach itself and the associated amenities in Shoeburyness, Essex. The grassed overflow car park historically suffered with the problem of vehicles wearing away the grass and creating ruts, with the area becoming uneven, unsightly and generally muddy and unpleasant in both wet and dry conditions.

GRASSPROTECTA (Heavy) was specified, as it met all the remedial requirements. Ruts were levelled with soil and then seeded, with the GRASSPROTECTA then being pinned to the surface with the supplied fixings. Additional gentrification work was also carried out on the site, creating a new and pleasant parking facility for the public to use.

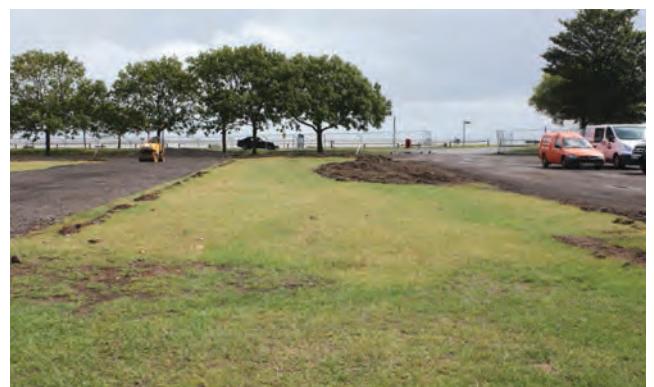
The customer and contractor were impressed with the speedy product delivery and the included easy to follow instructions. The rolls were unwound and aid out to relax, then cut to size and pinned in position. The whole installation procedure was completed in a couple of days.

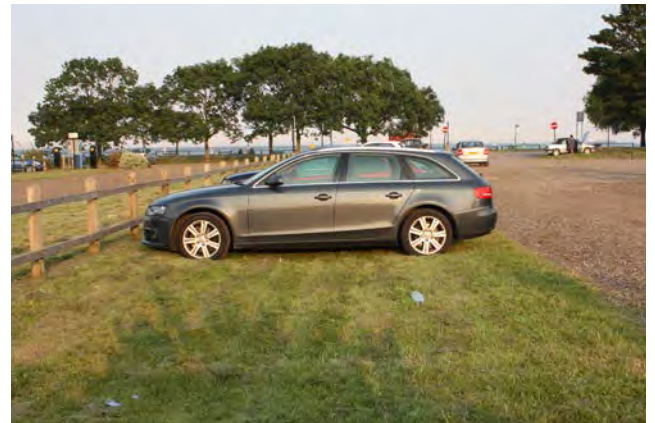
With regular watering, the existing grass sward and the newly sown seed, established through the mesh within weeks, creating a strong intertwined surface layer ready for use. The customer was very pleased with the product quality and the final aesthetic finish of the car park surface.
