Case Study

Drainage to the rear of a retaining wall

Client: Carluke Station Park & Ride
Project: Station access ramp, Carluke

Product(s): TERRAM™ Drainage Geocomposite 1BZ

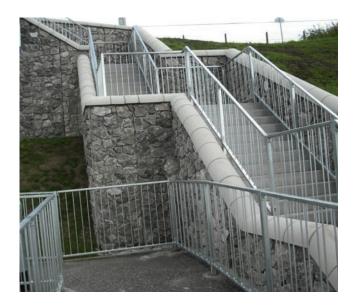
The impermeable LDPE component of the 1BZ drainage composite waterproofs the wall whilst the high flow rate and filtration provided by the geotextile filter and the polymer core ensures that the water drains away rapidly, maintaining soil stability and alleviating hydrostatic pressure.

"The flexibility and easy handling of the TERRAM 1BZ drainage composite made installation very simple and problem free", said Scott Rowan, George Leslie's Site Agent for the Carluke construction project.

At Carluke, TERRAM 1BZ was fixed to the access ramp's retaining structure prior to the introduction of the backfill material. The TERRAM 1BZ was positioned so that it would act as a vertical channel, directing excess groundwater into a perforated drainage pipe at the base of the walls which would be carried to the nearest main drainage system.
